An In Vitro Evaluation of Dentinal Crack Formation by Conventional Hand Filing and Three Different Rotary File Systems

Type of Publication: Original Research Paper

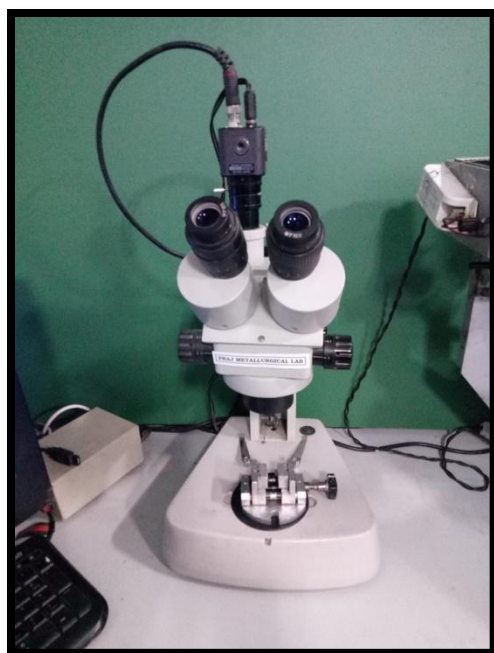
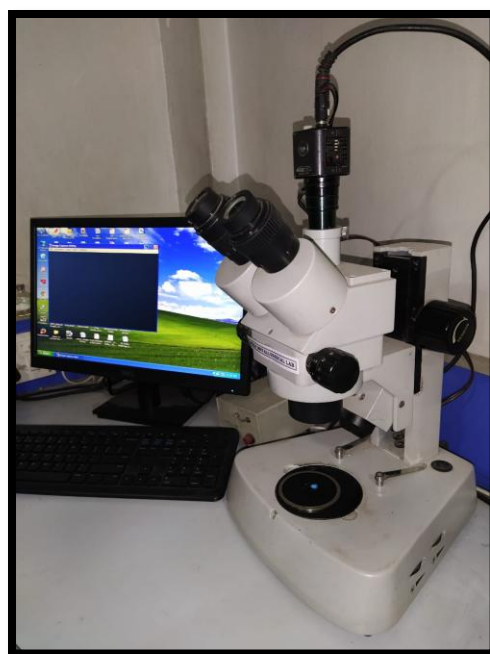
(a) Front view

(b) Side view

Fig 2: Stereo Microscope (Model: XTL 3400E, Magnification: 25X)

The slices were then view through a stereo microscope (Model: XTL 3400E, Magnification: 25X). (fig.2)

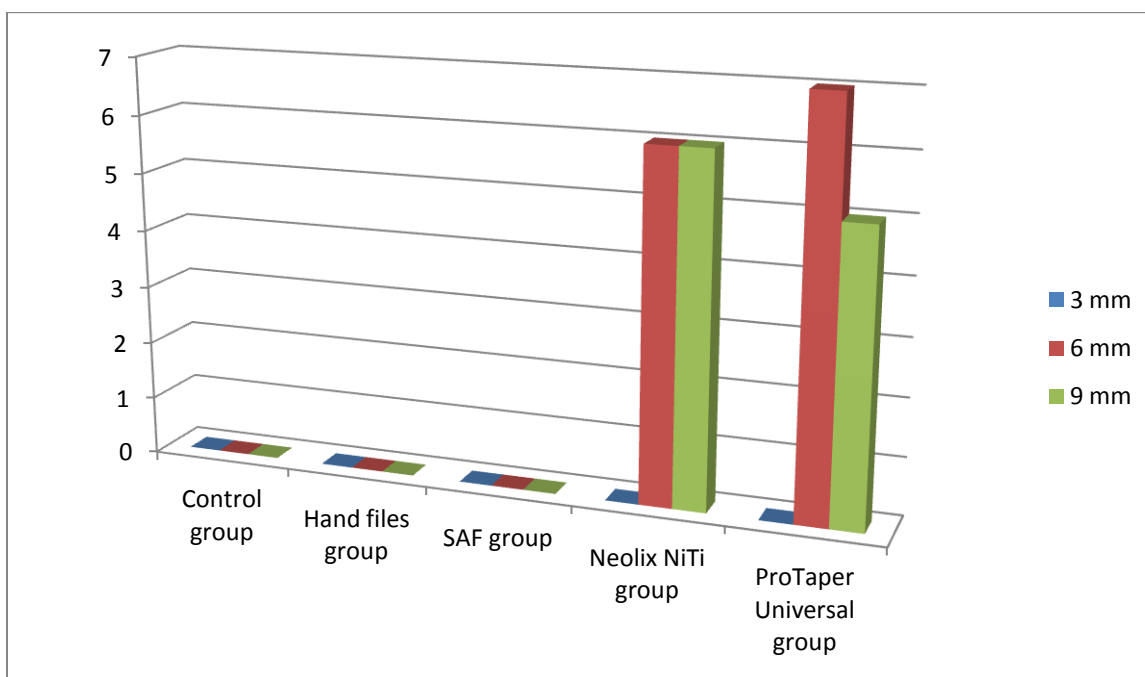
Graph 1: Comparison of defects among all study groups.

The unprepared canals (the control group), the HF group and SAF group presented no defects. Defects were found in all NiTi rotary file groups (Neolix NiTi, ProTaper Universal).The percentages of roots with defects in each groups at coronal, middle and apical thirds are shown in tables 1 and graph 1.

In the coronal third section, Group 5 showed maximum number of fracture cases (13) and Group 4 showed lesser number of cases (6). While, Group 3, Group 2 and Group 1 showed no fracture cases (0).

In the middle third, Group 5 had maximum number of fracture cases (7) while Group 4 showed lesser number of fractures (6). Group 3, Group 2 and Group 1 did not show any fracture cases (0).

In the apical third, Group 4 had maximum number of fracture cases (6) while Group 5, Group 3, Group 2 and Group 1 showed no fracture cases.

However, maximum defects were seen in group 5 (ProTaper Universal) followed by Group 4 (Neolix NiTi). However, no significant difference was detected among group 1, 2, 3 i.e. no defects ($p>0.05$)
