Surgical Removal of Fractured Endodontic Instrument in the Periapex via open approach-A Clinical Case Report

Type of Publication: Case Report

The purpose of this article is to present the surgical removal of a broken endodontic file from the periapical region of the lower premolar. The methods of diagnosis and measurement of the distance of the instrument to the adjacent vital structures in the periapical region was done with simple means and in an economical manner.

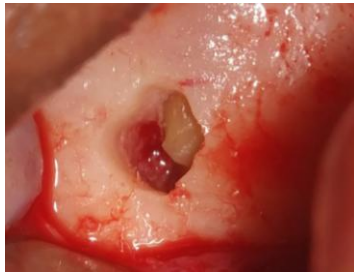
Fig 1: Surgical exposure of peri apex area

The procedure was performed under local anesthesia 2% lignocaine with 1:80,000 adrenaline. A crevicular incision was given from the mesial aspect of the mandibular left first pre-molar till the distal aspect of the mandibular left second molar and a mesial releasing incision extending into the vestibule was taken to raise a triangular flap. Subperiosteal reflection was done. A 5 mm bony window was prepared through the buccal cortex corresponding to the root apex of the premolar at the previously calculated length (Figure 1). The instrument was carefully visualized and then removed with a mosquito forceps (Figure 4). A post-operative radiograph was taken to confirm complete removal of the fractured segment. Next, the canal was obturated using 6% gutta-percha and 4% accessory cones and AH plus Sealer (Dentsply, Maillefer). The gutta-percha was burnished at the apical end of the distal canal with a hot burnisher. The wound was then curetted, and irrigation was done with normal saline. Demineralised freeze dried bone allograft was used to graft the surgical site and closure was done with 3-0 silk (Figure 5). Patient was prescribed amoxicillin 500 mg/8 h for 7 days, ibuprofen 600 mg/8 h for 3 days, and 0.12% chlorhexidine gluconate mouthwash

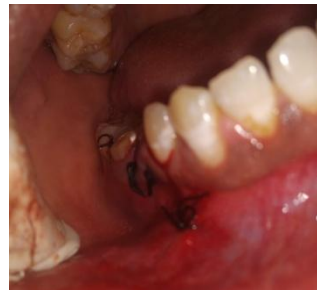
Fig 5: Surgical wound closure

thrice a day for 7 days. After 7 days, the patient was recalled for suture removal. A post-endodontic restoration was done. At the 6 month recall examination, the mandibular premolar was asymptomatic with progressive regeneration of the periapical bone.

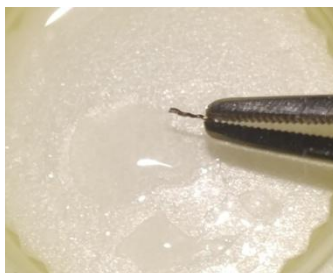
Fig 4: Retrieval of the broken file
