Identification And Management Of A Rare MB3 Canal In A Maxillary Molar: A Case Report

Type of Publication: Case Report

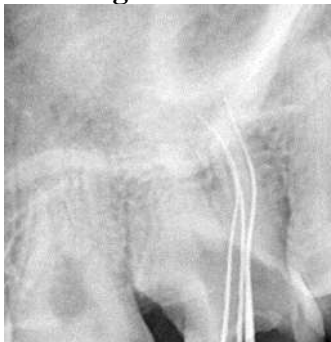
Fig.1 Radiograph showing 3 canals in the mesiobuccal root

Following this surprisingly, **two additional canal orifices** were discovered in line with the MB1 canal [Fig.2]. Using a No.10 K-file, both canals were gently negotiated and followed to a considerable working length without difficulty. These were presumed to be **MB2 and MB3**. A radiograph was taken and confirmed the presence of three canals in the mesiobuccal root [Fig 1]. Interestingly, the MB2 and MB3 canals were seen to **merge in the apical third** of the root.

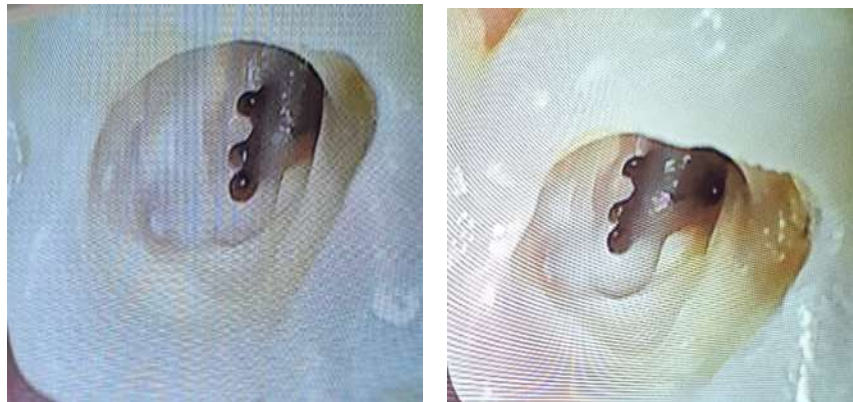
Fig. 2 Intraoral images of the access opening showing three canals in the mesiobuccal root (Images taken through intraoral camera)

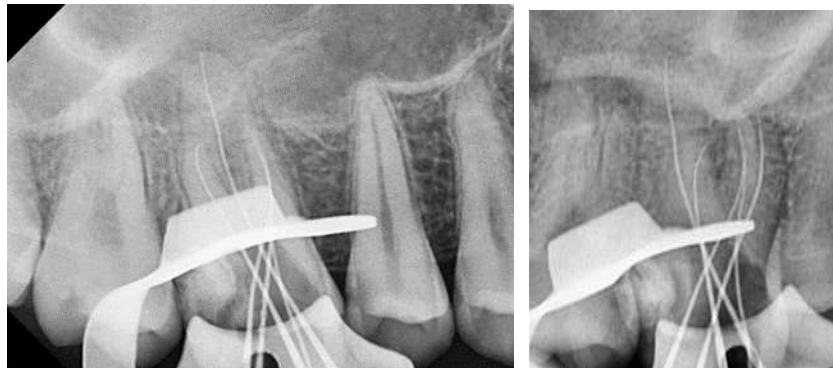
Fig. 3 RVG Radiographic images showing working length confirmation for the canals : MB1, MB2, MB3, DB and P

The working lengths of all canals were confirmed with an **Electronic apex locator and Radiograph** [Fig 3]. Root canal shaping and cleaning were done using **rotary NiTi files**, under copious irrigation. **5.25% sodium hypochlorite** was used as the main irrigant, interspersed with **normal saline**. **EDTA** solution was used as a chelating agent and lubricant. After the final rinse with normal saline, canals were dried with sterile paper points.

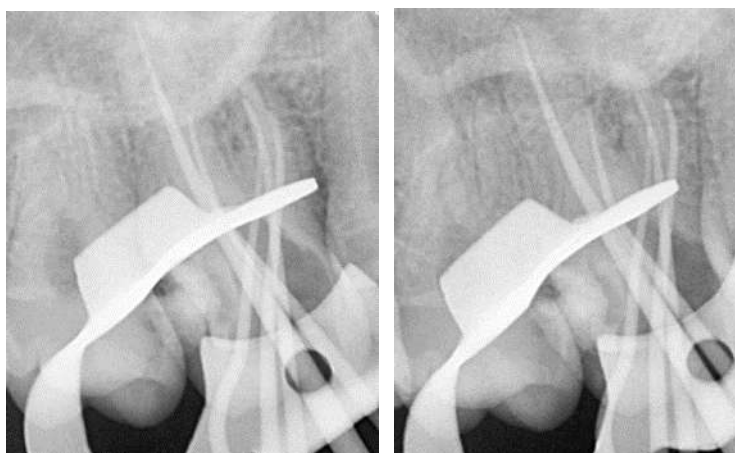
Fig.4 RVG Radiographic images showing Mastercone selection for the canals : MB1, MB2, MB3, DB and P

For obturation, **bioceramic sealer** was used. The **palatal canal** was filled with a **25.06 gutta-percha cone**, and the **distobuccal, MB1, MB2, and MB3** canals were filled using **25.04 gutta-percha cones** [Fig 4]. A postoperative radiograph confirmed the quality of the obturation, including the merging of MB2 and MB3 [Fig 5].

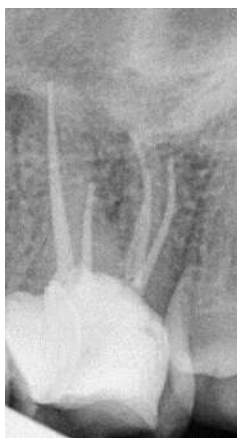
Fig.5 Post-operative RVG Radiographic image showing successful endodontic management for maxillary 1st molar
