## Integrating Techniques in Aesthetics: Modified Putty Index and Direct Composite Veneer Cases

Type of Publication: Original Research Paper

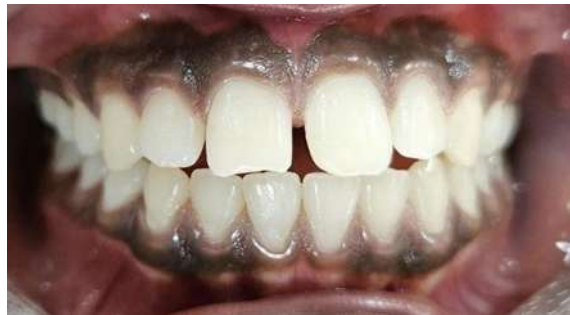
**Fig1. Preoperative photograph showing midline diastema**

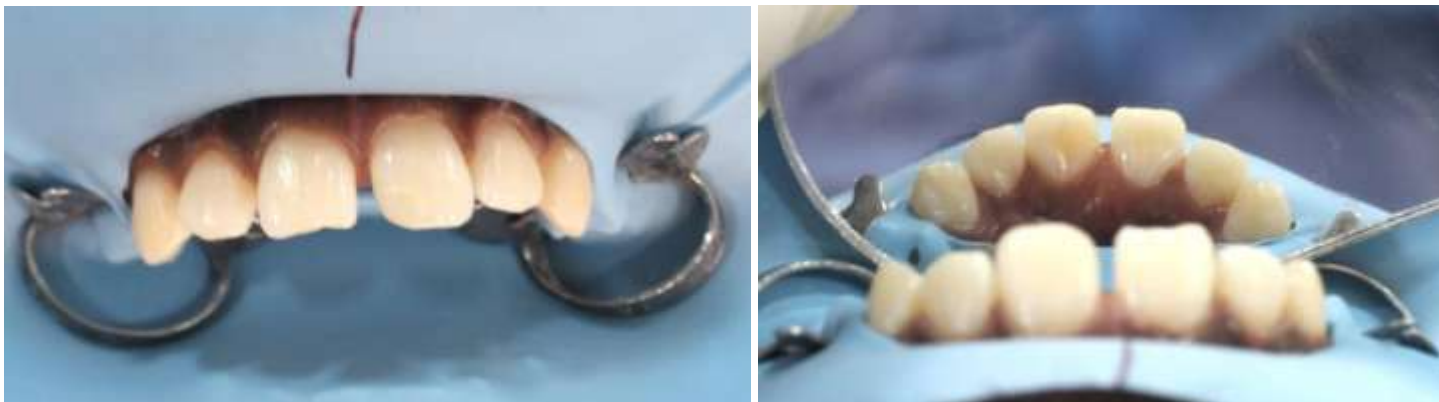
**Fig 2. Rubber Dam isolation with split dam technique**

As per the patient's request, a single-visit treatment plan was chosen. Rubber dam application was done. (Fig.2) A preliminary impression was taken with silicone impression material palatally.(Fig.3) The section was checked intraorally for accuracy of fit, which would later function as a reference guide and rigid template for reconstructing the palatal enamel.

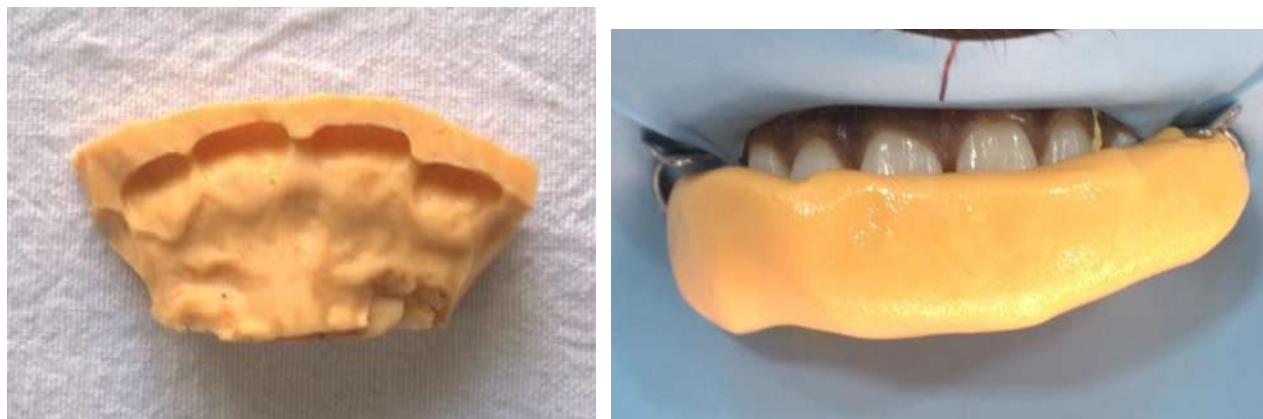
**Fig3. Impression of the teeth taken with addition silicone to obtain a putty index**

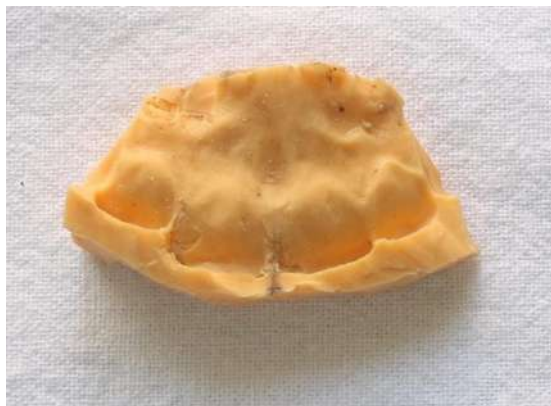
**Fig 4. Modified Putty index    Fig 5. Removal of old composite restoration**

The impression was the modified chairside(Fig.4) during the same appointment to match the desired final contour, and its palatal adaptation was re-verified intraorally. The index was cut at the desired locations to facilitate the placement of the mylar strips between the two teeth to be restored. It maintains the proper midline contour of both the teeth.

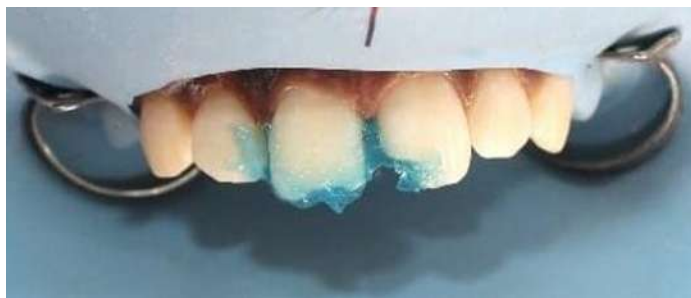
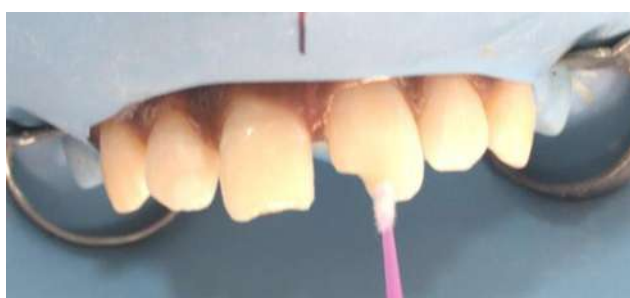
**Fig 6. 37% phosphoric acid etchant is applied    Fig 7. Application of bonding agent**

The old restoration was removed and a long bevel was prepared on the labial surface of the teeth to eliminate unsupported enamel margins and enhance the available surface area for bonding. (Fig.5) Shade selection was done using the button method. All exposed facial and lingual surfaces of the affected teeth were etched with 37% phosphoric acid for 15

seconds, followed by the application of a bonding agent which was then cured. (Fig.6 and Fig.7)

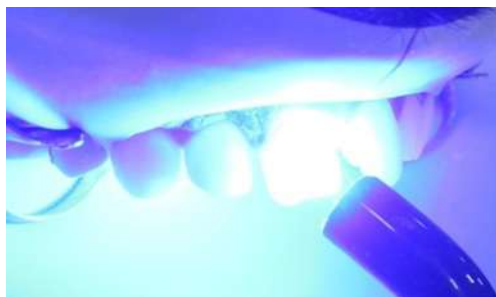
**Fig 8. Curing of composite**

A thin layer of composite resin was then adapted onto the palatal portion of the modified putty index, positioned intraorally, and light-cured for 30 seconds. The matrix was carefully removed, leaving a stable palatal layer of composite bonded to the teeth. The teeth were then restored individually by incrementally adding composite over this rigid palatal foundation. (Fig.8 and Fig.9)

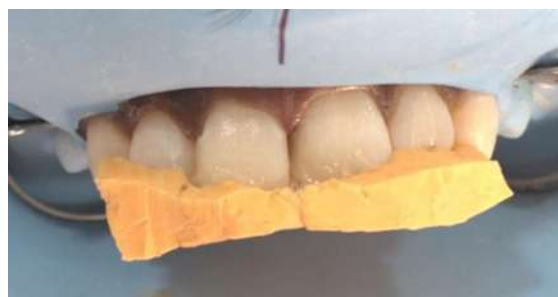
**Fig 9. Composite buildup with the help of index**

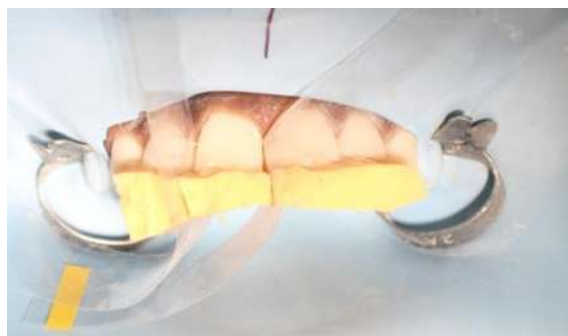
**Fig 10. Placement of mylar strips to achieve contour**

The mylar strips were placed and proximal contours were adapted. Occlusion was evaluated and necessary adjustments were made, followed by finishing and polishing with polishing discs.

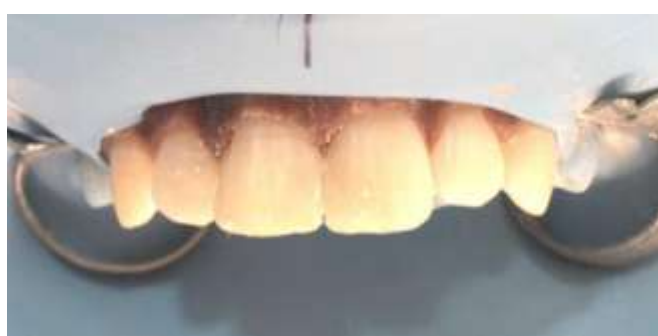
**Fig11. Completion of composite buildup**

Interproximal areas were refined using finishing strips, and the patient was provided with oral hygiene instructions for maintaining the restorations. (Fig.11)

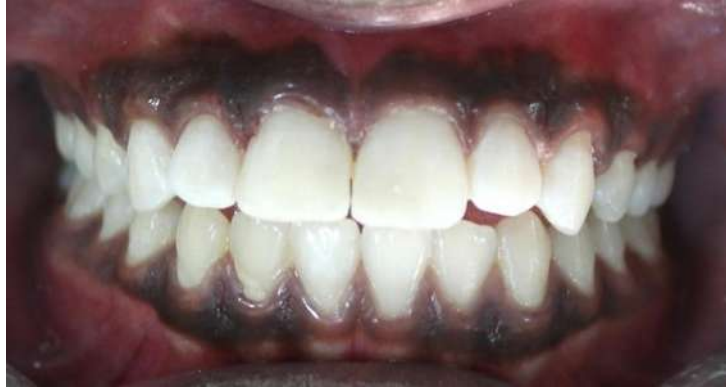
**Fig12. Final Composite Resin Restoration after finishing and polishing**

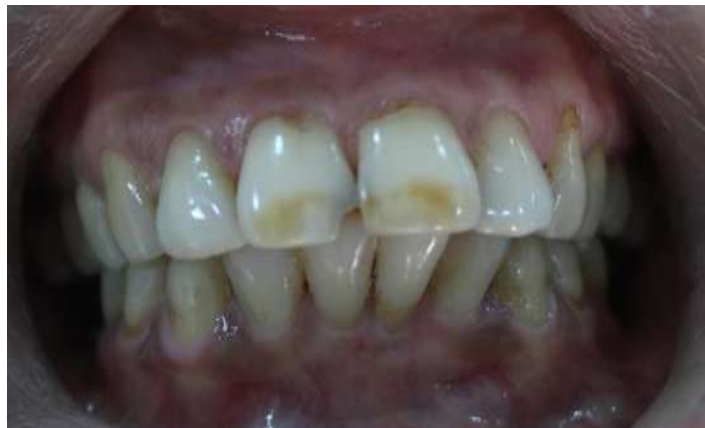
**Fig.13 Preoperative photograph showing fluorosis**

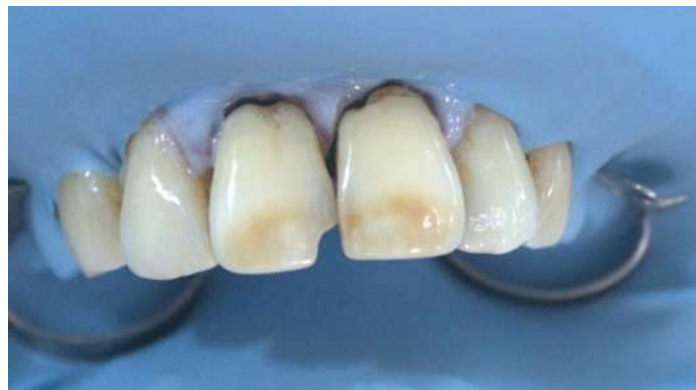
**Fig.14. Rubber Dam Isolation with gingival retraction cord placement**

Following rubber dam isolation, removal of caries was done (Fig.14). Under water cooling, 0.8- mm-deep preparations were made on the labial surfaces of the teeth. The cervical margins were positioned at the level of the gingiva by creating a cervical step, ensuring the natural gingival contour was not disturbed. (Fig.15)

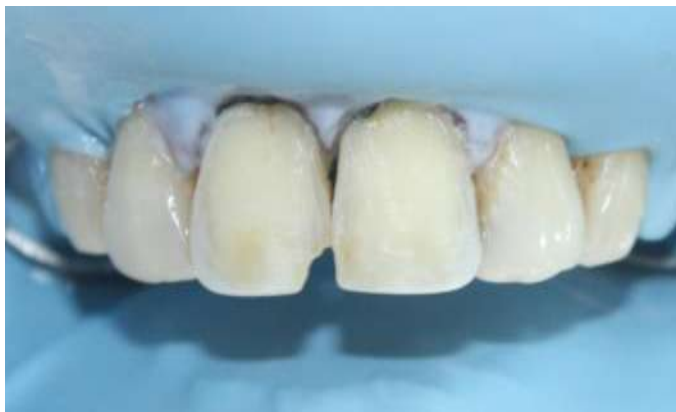
**Fig15. Preparation of margins**

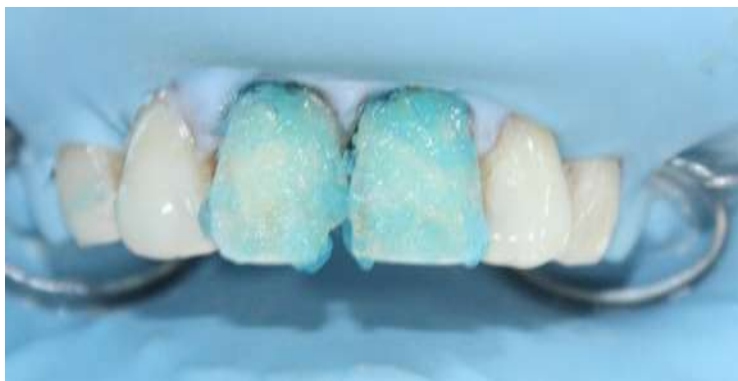
**Fig16. Acid etching of the teeth**

Shade was selected as B1 on the Vita scale. 37% phosphoric acid was applied to the enamel surfaces for 15 seconds, rinsed with water spray for 20 seconds, and gently air-dried. A bonding agent was then applied

in two layers using an applicator tip and light-cured for 20 seconds. (Fig 16 and Fig.17)

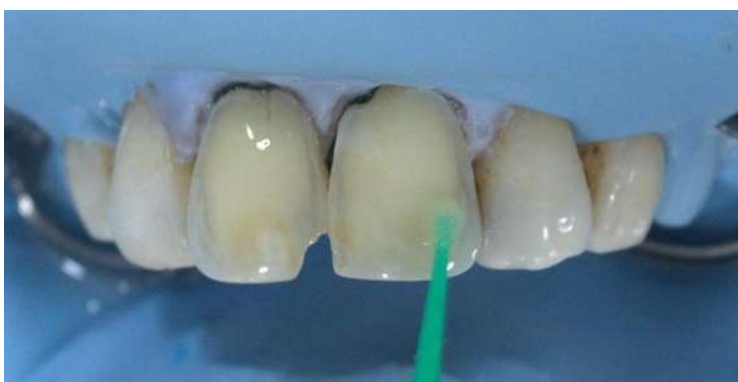
**Fig17. Bonding Agent is Applied**

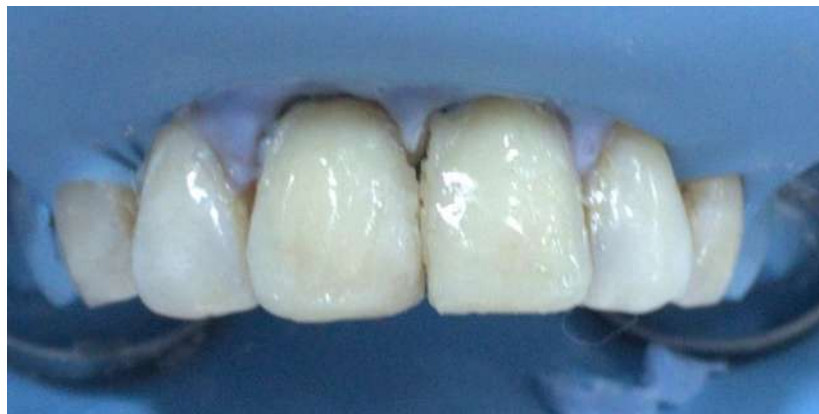
**Fig 18. Composite Layering Done**

In order to mask the discolorations on the prepared surfaces, opaque A2 shade composite resin was applied to and polymerized with a light-curing unit. Later, the cavities were filled with B1 shade of composite resin incrementally and polymerized each time for 20 secs. (Fig .18)

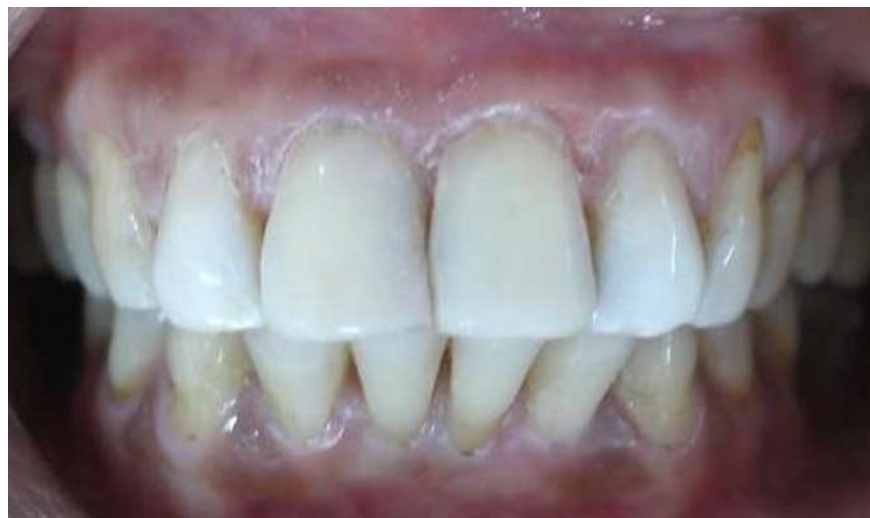
**Fig19. Finishing And Polishing Done**

Finishing and polishing procedures were done. (Fig.19)
